Survival Factors and Biomechanics Factual Report In support of the General Aviation Airbag Study

November 16, 2009

Location: Stigler, OK
Aircraft Type: Cessna 182T
Accident Date: 4/9/2009
Accident Time: 2115Z
Accident Number: CEN09LA247
Airbag Equipped: ☒

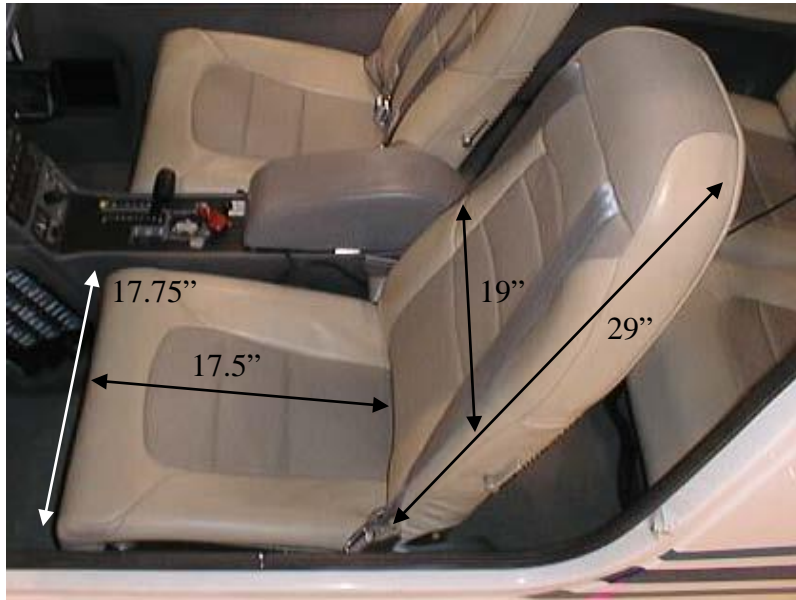
Figure 12: Dimensions of the 1st row seats (displayed on a generic general aviation seat).

The pilot's seat was found in the 1st pin position (full forward). The passenger seat was in the 9th pin back from full forward. There were 14 total pin positions for each front seat. Damage was also noted to the front edge of the pilot's seat track and can be seen in Figure 11. General dimensions of the seats in the first row are shown in Figure 12. The seats are assembled by Cessna and are not specifically marked with any tracking numbers.

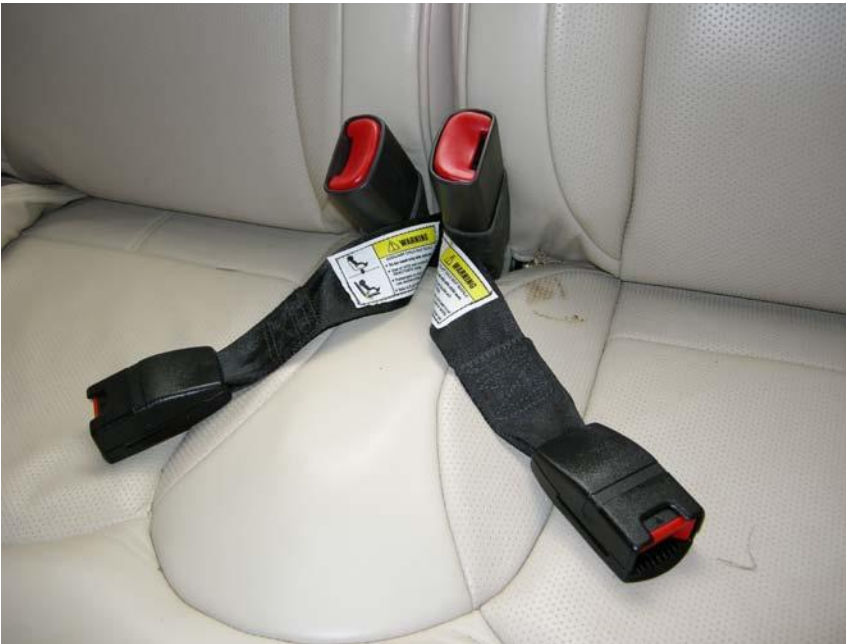
Figure 15: The primary (top) and secondary (bottom) buckles for the rear seat occupants can be seen in this photograph.

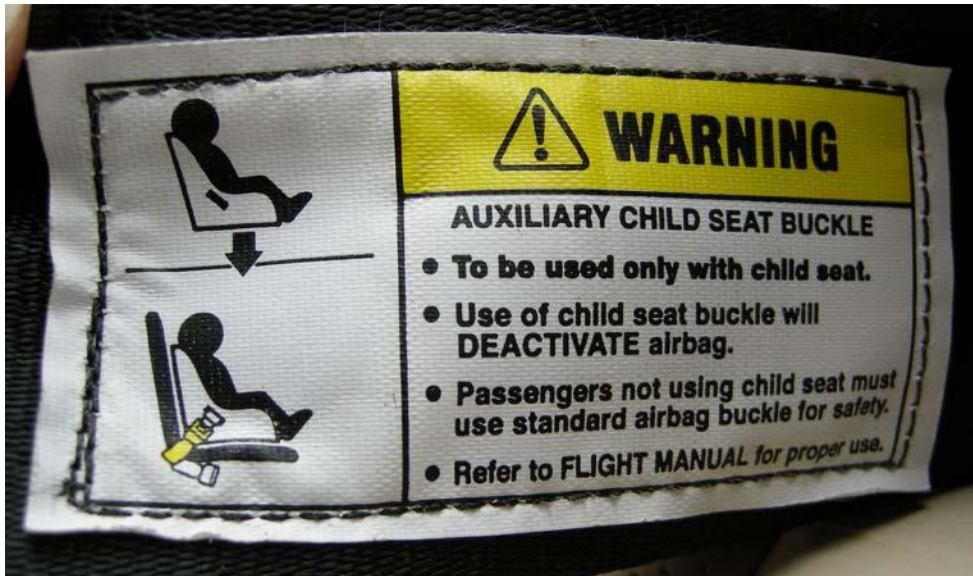
Figure 16: A photograph of the label stitched to one of the secondary buckles in the rear seat.

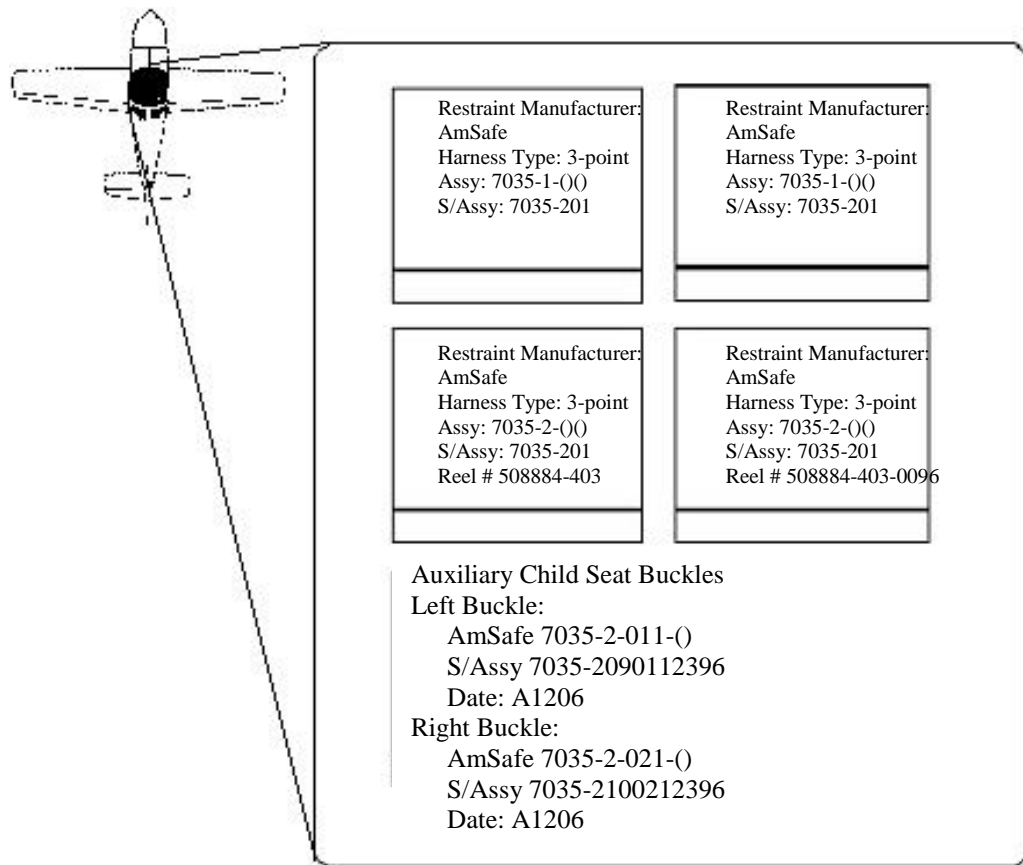
Figure 18: Restraint identification numbers.

Both the left and right front seat restraint inertia reels were functional, post-accident but the webbing in the right front restraint would not fully retract into the reel. The inertia reels were functioning properly for the two rear seats. Prior to moving the accident aircraft, the restraint systems were examined to document latch position and potential load marks. The distance from the anchor bolt to the load bar for all four seat positions in the post accident position is detailed in Table 2. Note that for the rear seats, the anchor bolt was inaccessible, and therefore the cushion reference point, the point where the belt emerges from the cushion, was used as the reference for those measurements. Load marks were found under the load bar in all seating positions except the right, rear seat. The front seating positions exhibited heavier load marks than the left, rear seating position. The position of the belt on the left rear seat when the load bar was placed over the load marks is shown in Figure 17. The restraint identification numbers are shown in Figure 18.

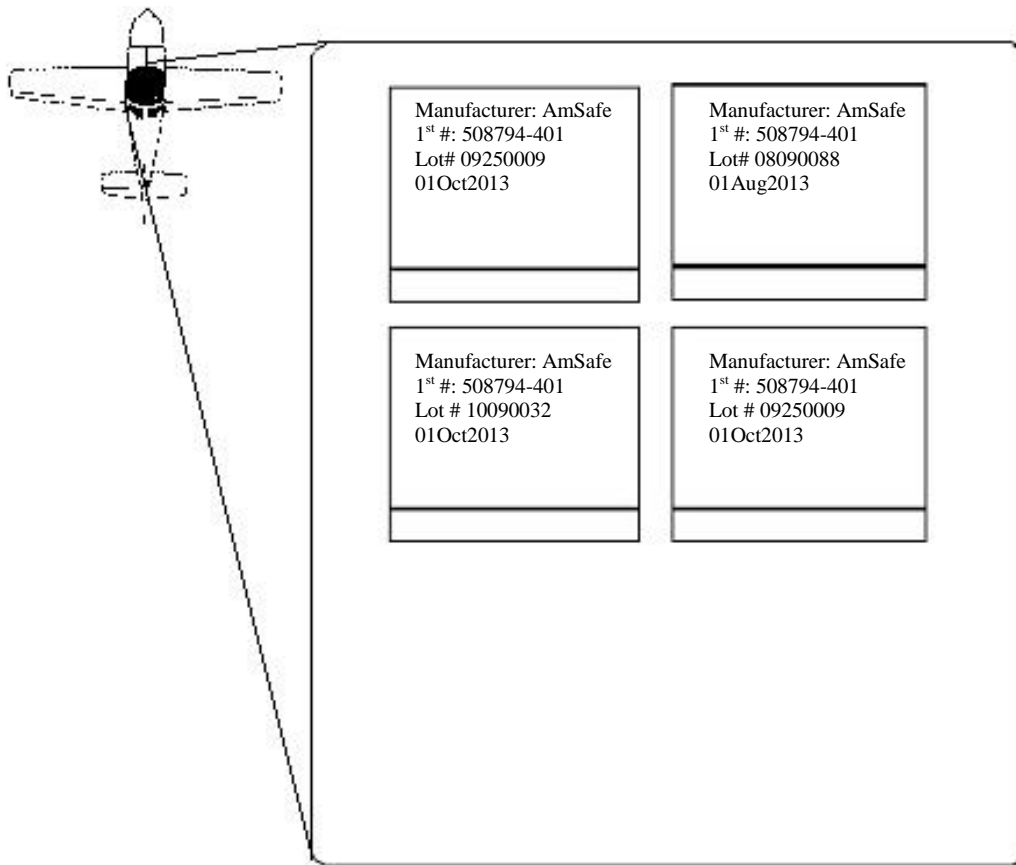
Figure 21: Airbag labels.

An AmSafe developed diagnostic test tool (P/N 508668-201) was used to assess the condition of the airbag system. The diagnostic tool was connected to each airbag system to assess whether the system was active and enabled. A green light indicates that the system is active and enabled. For all four airbags, the diagnostic tool showed a green light indicating that the system was active and enabled. (See Figure 19.) When the belt was fastened into the auxiliary child seat buckles, neither rear seat airbag was enabled. (See Figure 20.) In addition, in a previous investigation, it was noted that the front seat belts could potentially be switched such that the belt for the right seat occupant was actually used by the left seat occupant. This case was tested with the diagnostic tool and showed that the airbag system for the left seat occupant would still be active and enabled except that the airbag would have deployed from the unused belt.
